Safety Inspection Report

Annual Inspection

Village Hall Play Area

28 May 2025

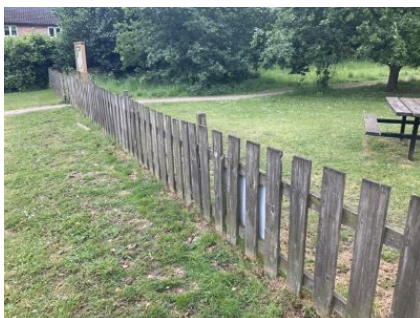
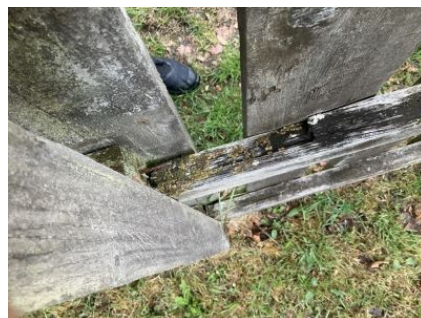
Moderate repairs are needed.

Monitor all timber items for decay throughout the year due to softening at ground level. Replace affected parts if found.
Multiple loose posts. Check for decay at ground level and reset if not found.

Check on a routine basis., Replace.

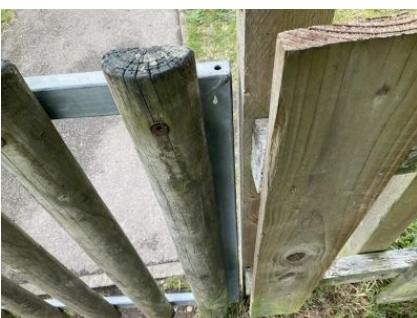
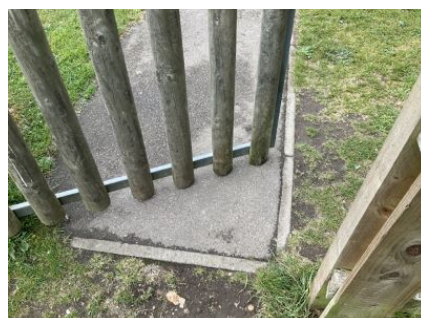
There is a crushing or shearing point on the side of the gate. Where the gaps reduce to less than 12 mm these have been known to cause serious, permanent injury to children, especially on the hinge side where the leverage forces are significant.

Gate sticks to the ground and also has potential finger entrapments/pinch points between the gate and slam post.

Adjust gate / posts / fit new rubber buffer to ensure a spacing of at least 12 mm throughout the range of the gate to remove the entrapment. The 12 mm gap also should apply on the hinge side of the gate.

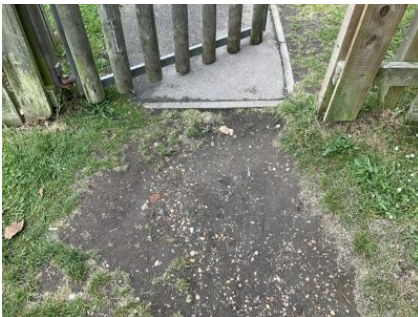
Surface is wearing.

Both entrances creating trip points.

Make good.

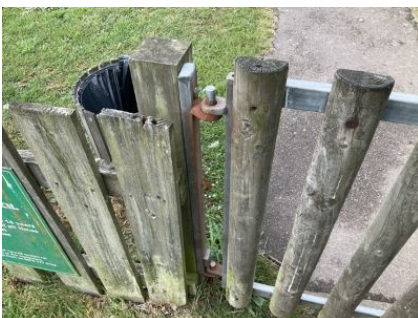
Moving parts require greasing.

Apply lubricant according to the manufacturer's instructions.

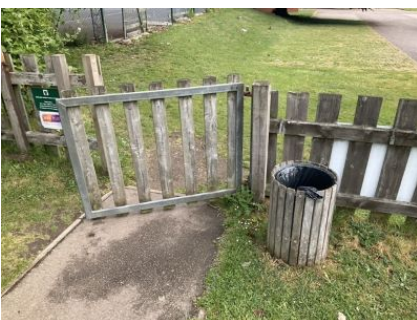
RoSPA recommends that litter bins should not be closer than 2 m from seats and gates (max of 3 m recommended). If they are too far away they may not be used. If they are too close this may cause nuisance from wasps.

Move the bin or seat as appropriate.

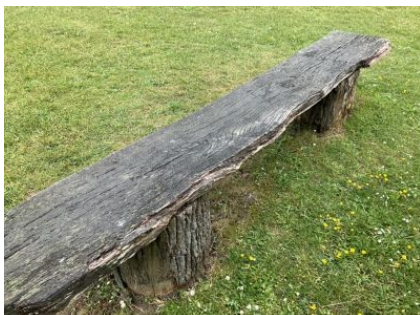
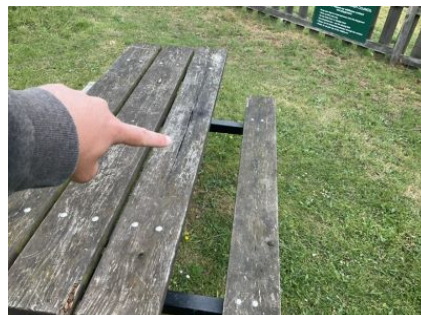
Timber is decayed.

Decayed and splintered timbers. Replace accordingly and repair splintered areas. Natural log bench supports and tops are decayed through and loose. Replace.

Replace affected parts., Repair.

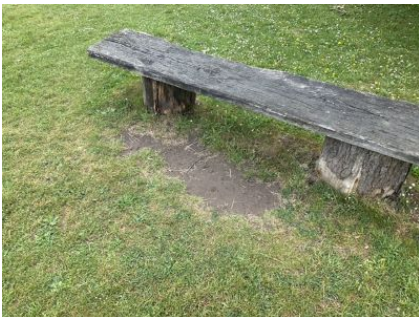
Worn ground areas.

Build up ground levels to remove trip hazard.

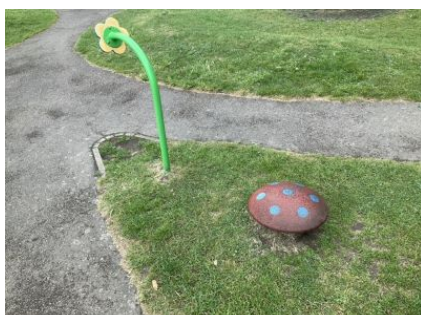
Additional comments are noted below.

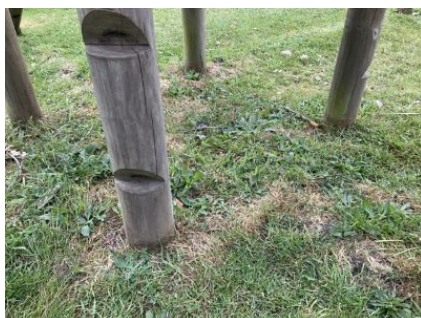
Strimmer damage is present on posts, allowing water to enter and timbers to soften. It can also remove the protective envelope around the timber. Prevent further damage and check timbers for decay throughout the year.

Prevent further damage.

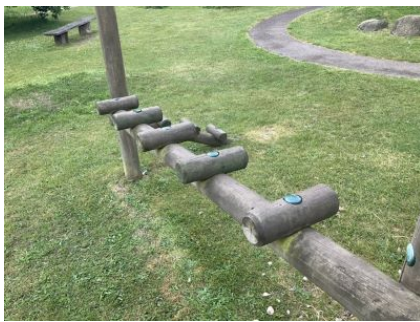
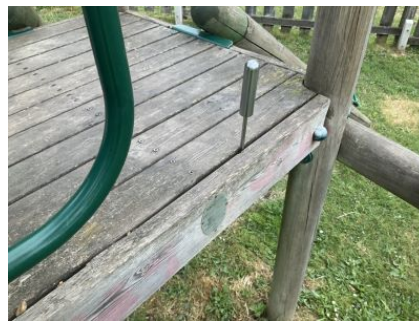
Bolt(s) loose.

Multiple foot holds. Tighten.
Platform edge timber/s are loosening allowing access of the finger probe. Secure timber ensuring a gap less than 8 mm.

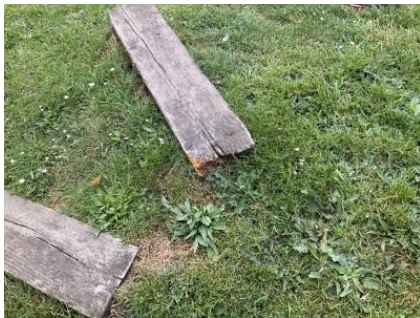
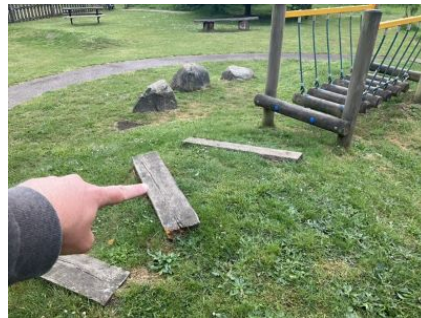
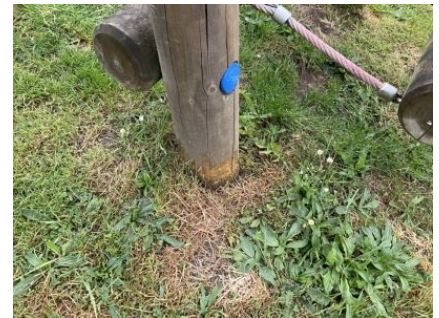
Strimmer damage is present on posts, allowing water to enter and timbers to soften. It can also remove the protective envelope around the timber. Prevent further damage and check timbers for decay throughout the year.

Excessive strimmer damage to sleepers accelerating decay around ends. Replace when necessary. Remove highlighted sleeper.
Strimmer damage is present. Prevent further damage.

Prevent further damage., Read the notes for further action.

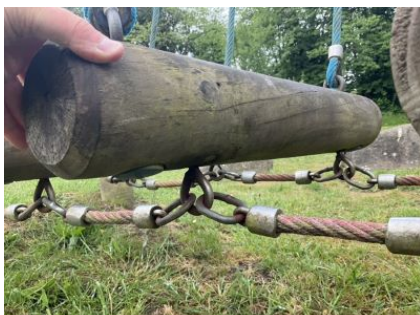
There is evidence of rusting or corrosion to the timber fixing bolts. This could be due to the bolts reacting with the timber preservative. We cannot gauge their condition without a dismantling inspection. This could present a significant risk of collapse.

Conduct a dismantling inspection, in consultation with the manufacturer, to determine the condition of the fixings.

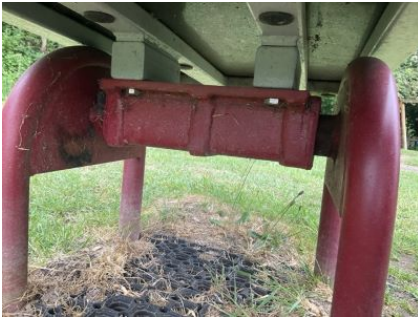
Grinding inside bearing. Dismantle and replace affected parts.

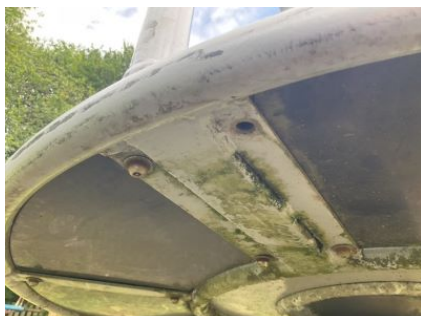
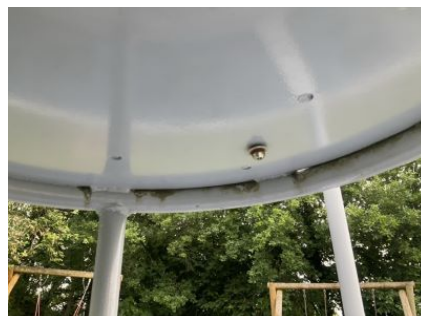
Fixtures loose or missing.

Bottom panel bolt/s missing. Replace.
Top panel bolts are loose and projecting. Secure.

Tighten/replace.

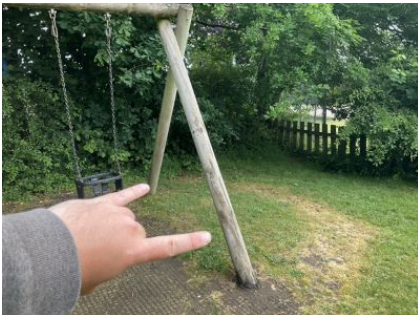
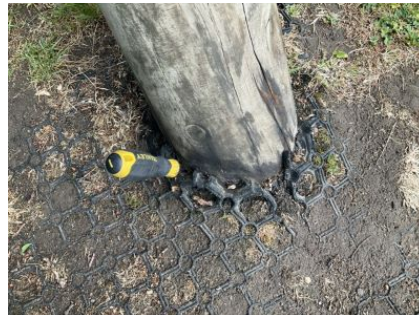
There is decay to timber components which may affect structural integrity. We do not recommend replacing rotten supports with timber posts which are directly set in the ground due to the increased problem of timber rot, especially in posts in contact with the ground.

Older two support legs are decayed through at ground level and becoming structurally weak. Replace.

Replace affected parts., Replace decayed components where possible and plan replacement of item. Check on a routine basis, especially at ground or foundation level.

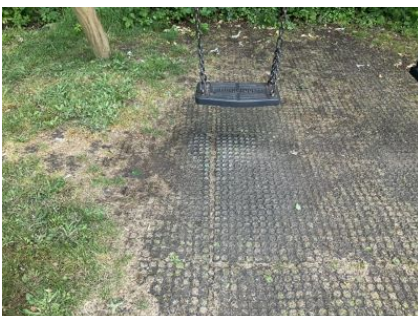
Surface needs repair.

Repair.

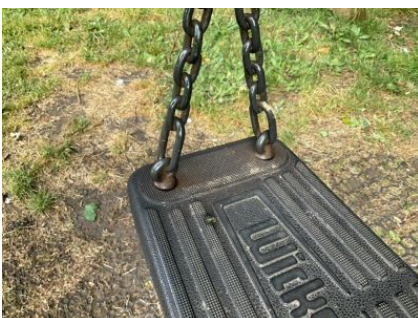
Loose swing seat eye-bolts.

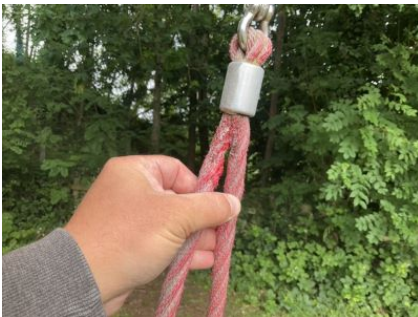
Due to arson damage. Tape over and replace when the metal core is damaged.

Repair.

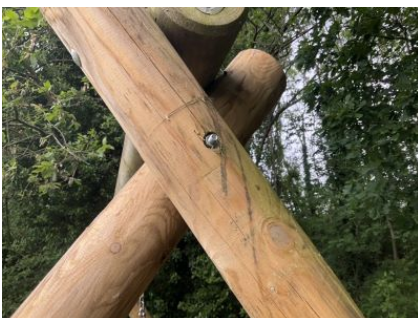
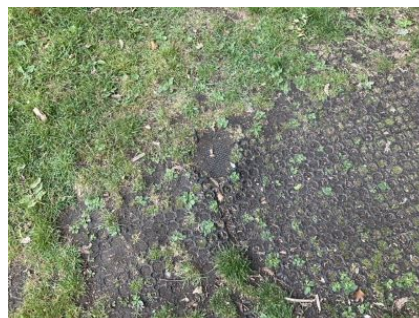
Minor repairs are needed.

Repair/replace damaged and lifting matting.
Cap/s are missing allowing water ingress into the frame and fixtures. Replace.

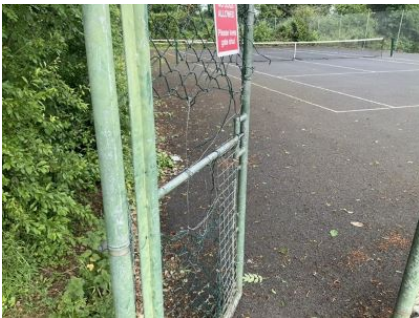
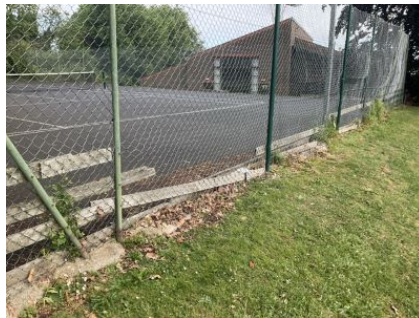
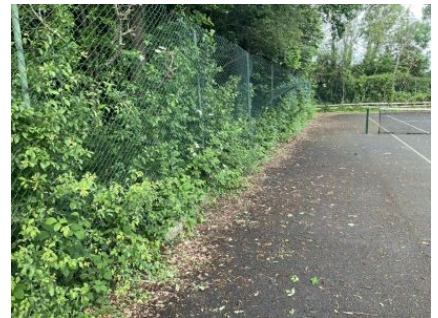
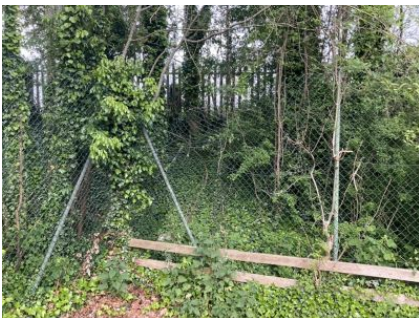
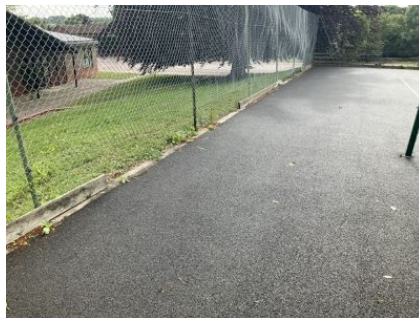
Moderate repairs are needed.

Mesh and timber boards damaged, loose and missing throughout. Repair and replace.

Repair., Replace.

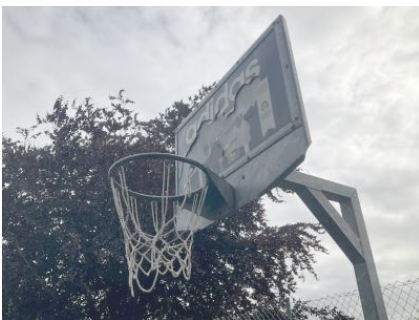
Item is damaged.

Backboard on basketball post, parts could fall onto a user below. Remove plastic/replace.

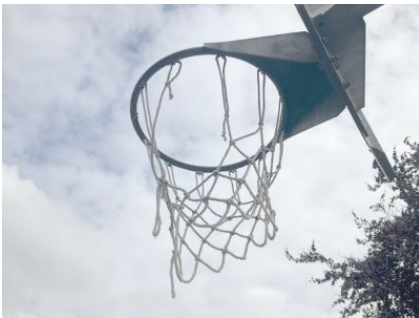
The netting is damaged.

Repair.
