# Safety Inspection Report

Annual Inspection

## Village Hall Play Area

Woolmer Green Parish Council

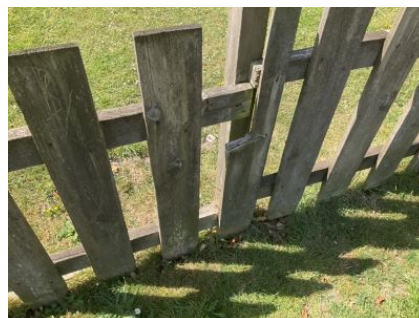
Moderate repairs are needed.

Monitor all timber items for decay throughout the year due to softening at ground level. Replace affected parts if found.  
Multiple loose posts. Check for decay at ground level and reset if not found.

Check on a routine basis., Replace.

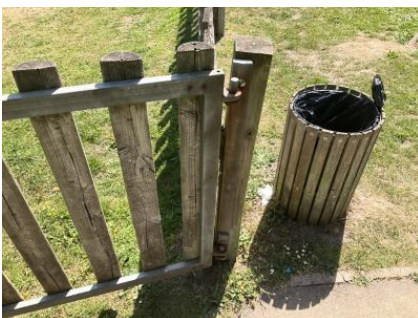
Surface is wearing.

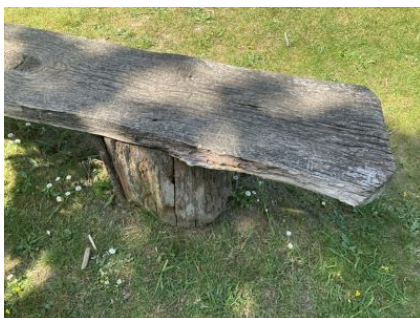
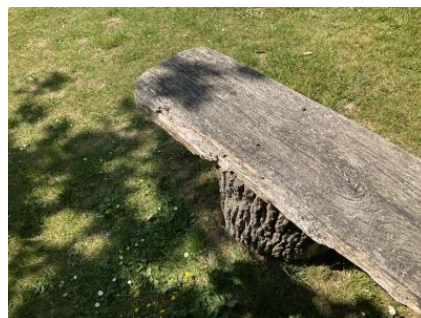
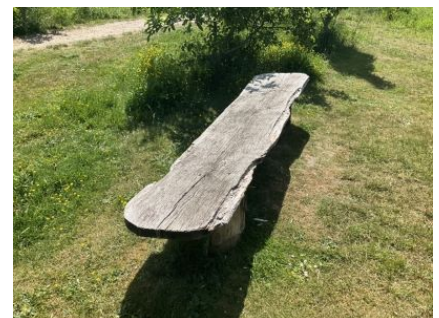
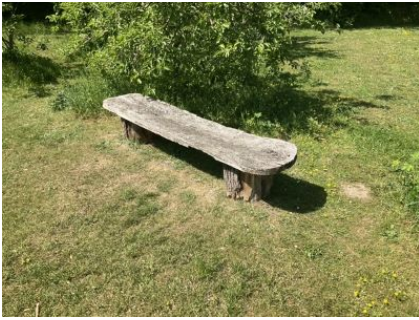
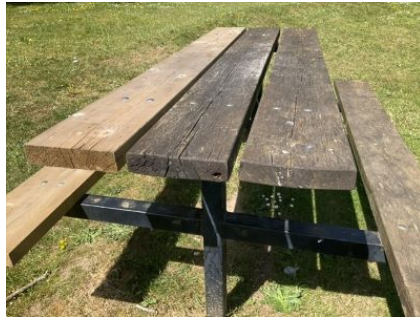
Timber is not in good condition.

Benches. Recommended these are replaced due to excessive levels of decay and loose sections.  
Decaying picnic table timbers. Replace when necessary.

Replace., Repair.

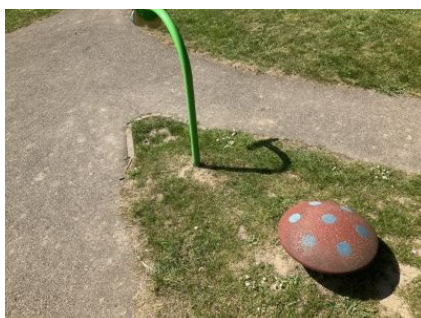
Additional comments are noted below.

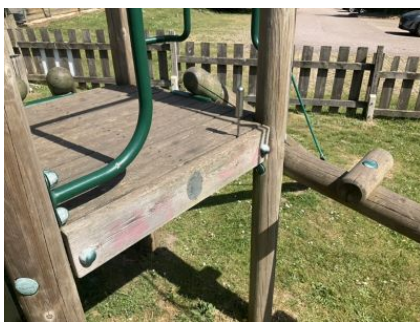
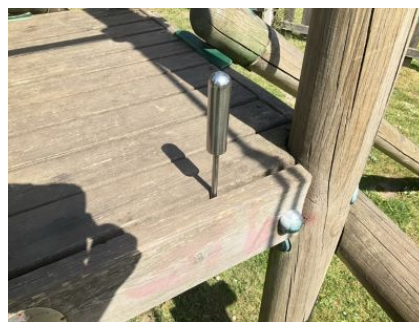
1. Strimmer damage is present on posts, allowing water to enter and timbers to soften. It can also remove the protective envelope around the timber. Prevent further damage and check timbers for decay throughout the year.
2. Bolt(s) loose.
3. Timber is splintered.

Platform edge timber/s are loosening allowing access of the finger probe. Secure timber ensuring a gap less than 8 mm.

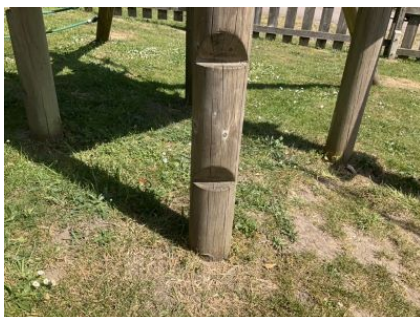
Strimmer damage is present on posts, allowing water to enter and timbers to soften. It can also remove the protective envelope around the timber. Prevent further damage and check timbers for decay throughout the year.

Prevent further damage.

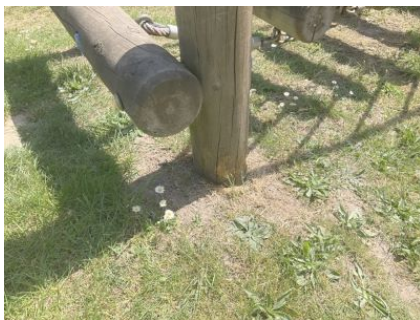
Strimmer damage is present on posts, allowing water to enter and timbers to soften. It can also remove the protective envelope around the timber. Prevent further damage and check timbers for decay throughout the year.

Strimmer damage is present. Prevent further damage.

Prevent further damage.

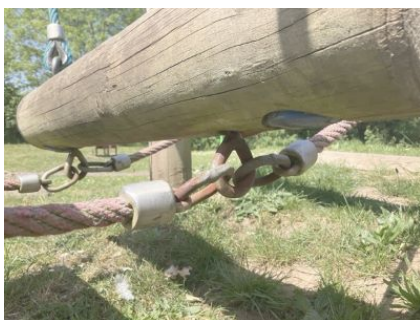
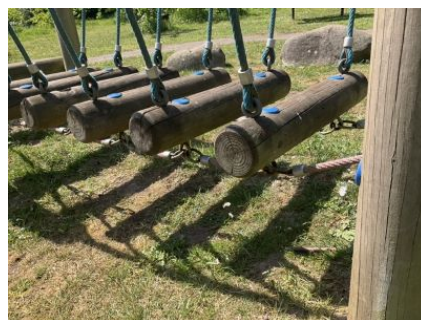
There is evidence of rusting or corrosion to the timber fixing bolts. This could be due to the bolts reacting with the timber preservative. We cannot gauge their condition without a dismantling inspection. This could present a significant risk of collapse.

Conduct a dismantling inspection, in consultation with the manufacturer, to determine the condition of the fixings.

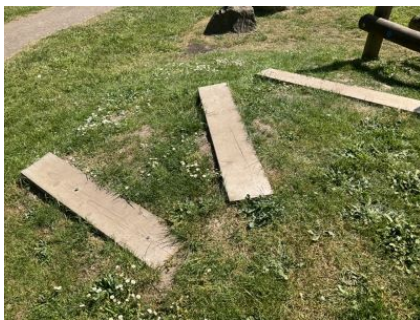
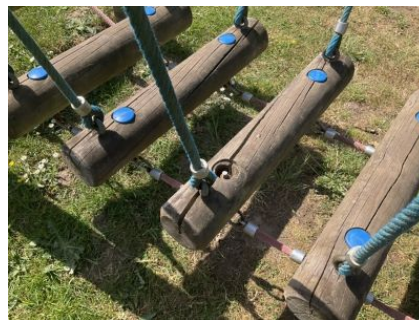
Minor repairs are needed.

Raised sleeper beams create trip points.  
Sleepers are slightly loose in the ground. Secure.  
Cap/s are missing allowing water ingress into the frame and fixtures. Replace.

Build up surface level to remove trip points., Repair.

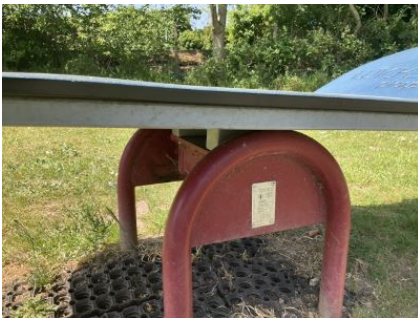
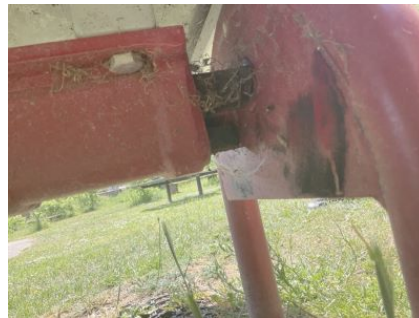
Grinding inside bearing. Dismantle and replace affected parts.  
Dampening sections are loose from mechanism.

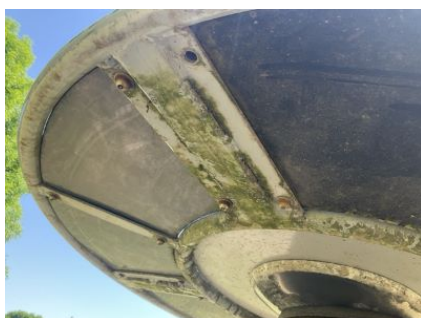
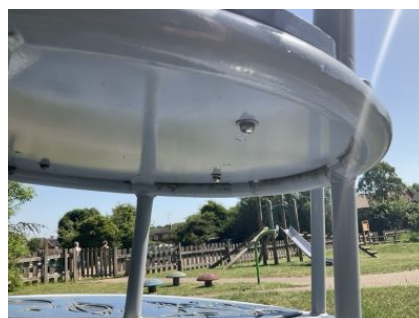
Fixtures loose or missing.

Bottom panel bolt/s missing. Replace.  
Top panel bolts are loose and projecting. Secure.

Tighten/replace.

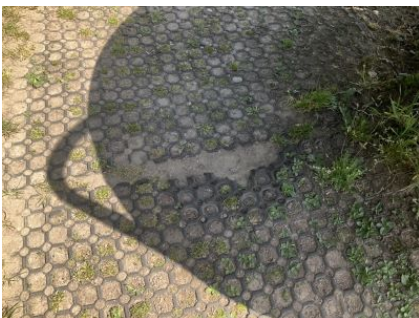
Surface needs repair.

Repair.

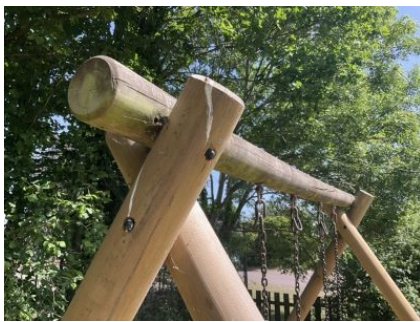
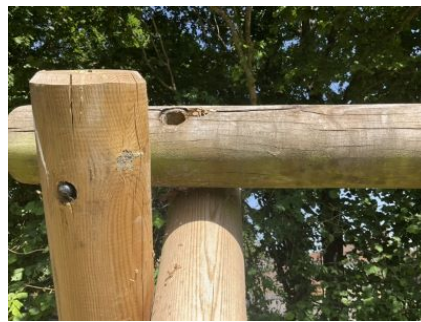
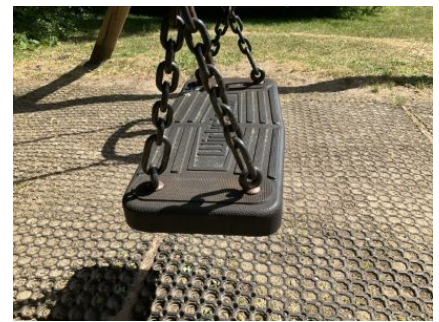
Fixtures loose or missing.

Top bar to new supports is very loose. Secure.  
Eye bolts on junior seat are loose. Secure.  
Cap/s are missing allowing water ingress into the frame and fixtures. Replace.

Tighten/replace.

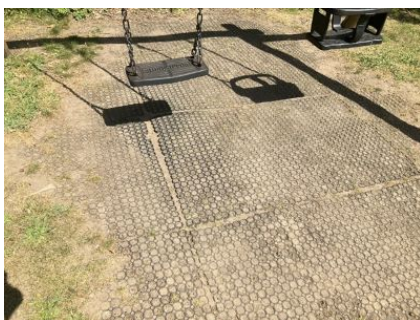
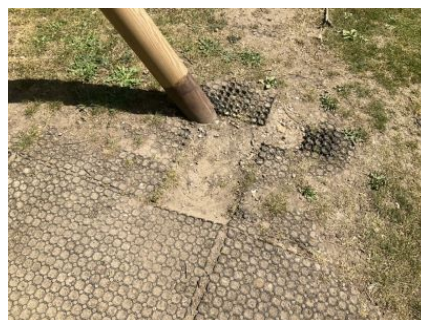
Surface needs repair.

Matting is separating. Repair.  
Matting sections are missing. Replace.

Repair., Replace.

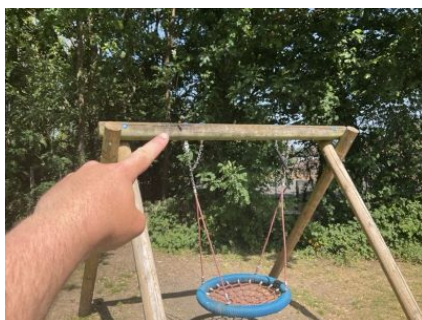
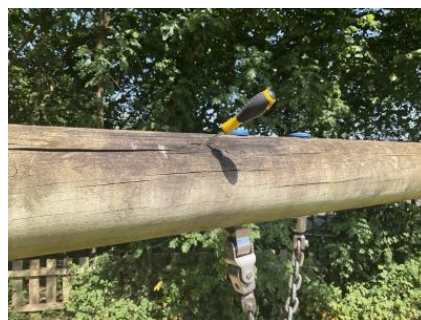
Timber is decayed.

Top bar is decayed through on top and darkening. Replace.

Replace affected parts.

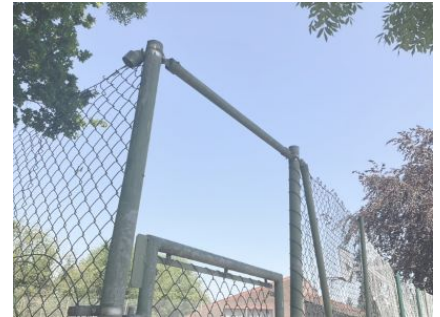
Moderate repairs are needed.

Mesh areas are damaged, loose and missing throughout. Repair and replace. Cut back all encroaching bushes and trees. Surface/the equipment are algae and moss covered, providing a slippery surface when wet. Sweep regularly.

Repair., Replace.
