Safety Inspection Report

Annual Inspection

Village Hall Play Area

28 May 2025

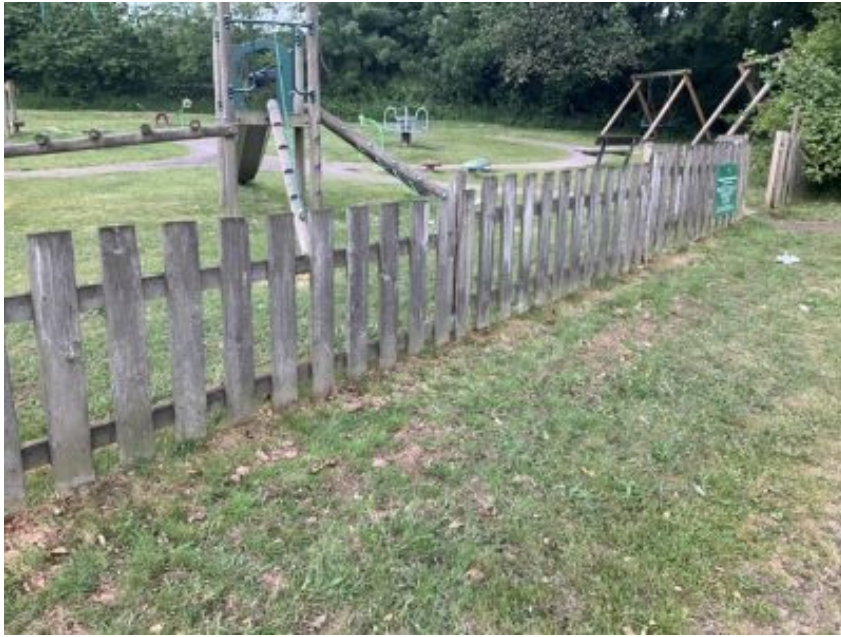
Fencing

Moderate repairs are needed.

Monitor all timber items for decay throughout the year due to softening at ground level. Replace affected parts if found.
Multiple loose posts. Check for decay at ground level and reset if not found.

Check on a routine basis., Replace.

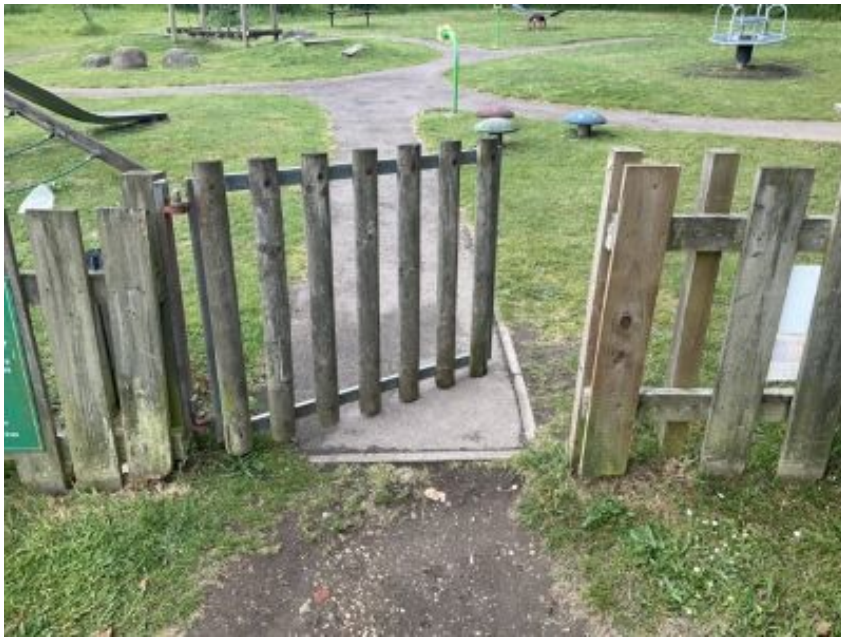
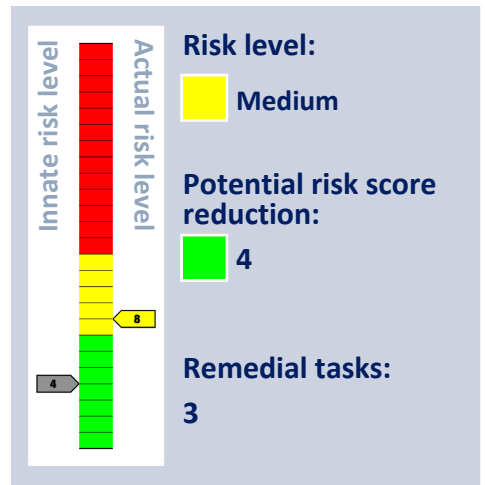
Gates

There is a crushing or shearing point on the side of the gate. Where the gaps reduce to less than 12 mm these have been known to cause serious, permanent injury to children, especially on the hinge side where the leverage forces are significant.

Surface is wearing.

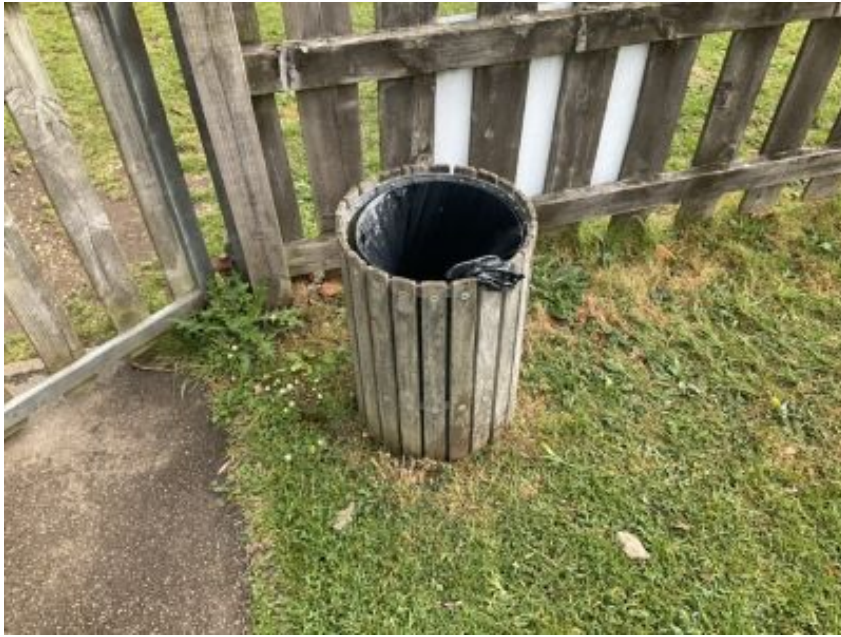
Litter Bin

RoSPA recommends that litter bins should not be closer than 2 m from seats and gates (max of 3 m recommended). If they are too far away they may not be used. If they are too close this may cause nuisance from wasps.

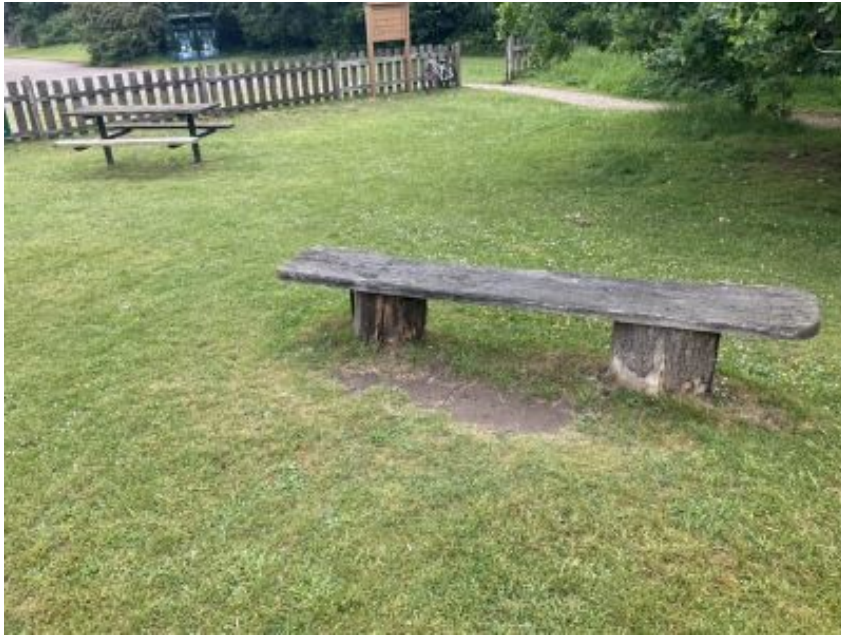
Seating

Timber is decayed.

Decayed and splintered timbers. Replace accordingly and repair splintered areas. Natural log bench supports and tops are decayed through and loose. Replace.

Worn ground areas.

Replace affected parts., Repair.

Build up ground levels to remove trip hazard.

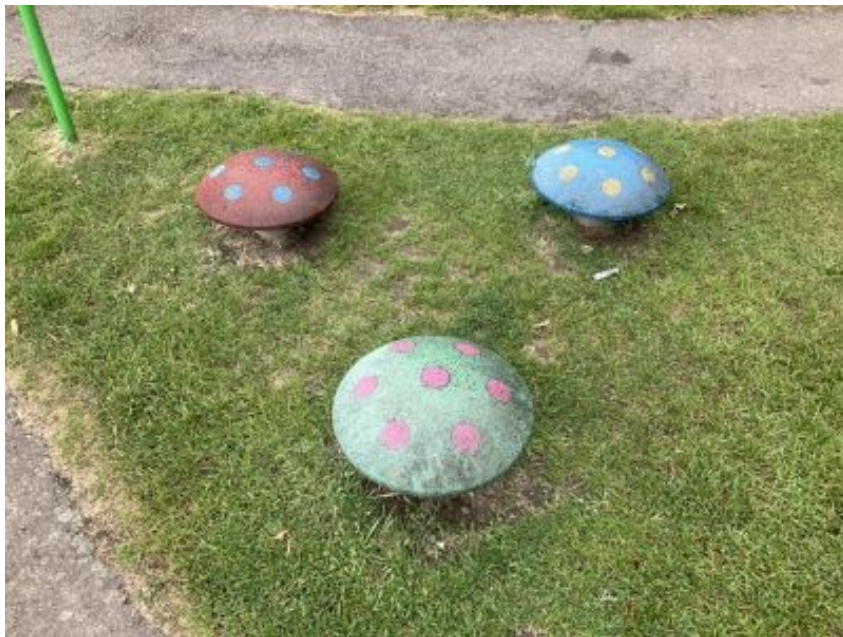
Play Seat - Mushrooms

Additional comments are noted below.

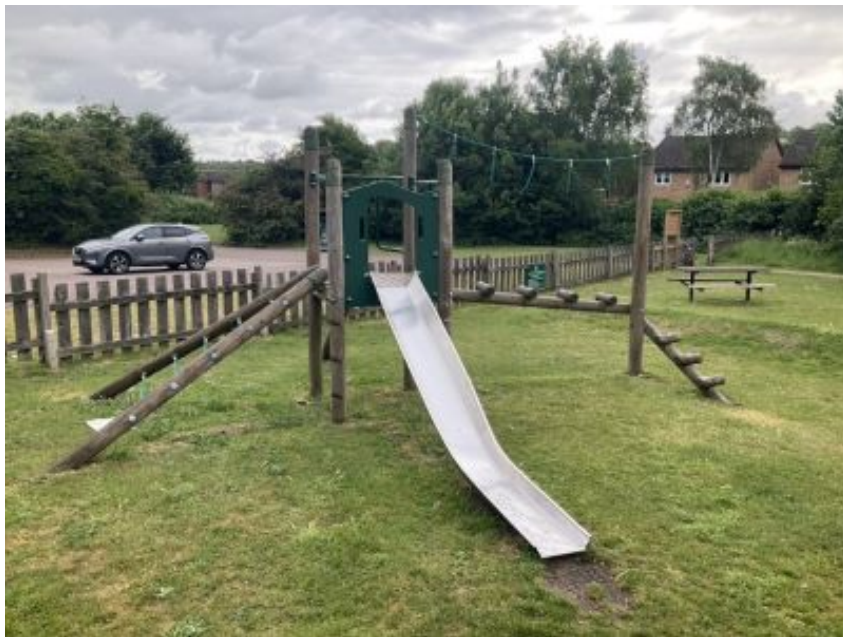
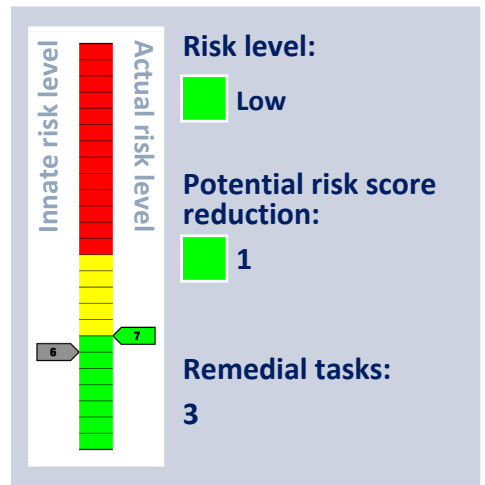
Multiplay - Slide Climber

Strimmer damage is present on posts, allowing water to enter and timbers to soften. It can also remove the protective envelope around the timber. Prevent further damage and check timbers for decay throughout the year.

Bolt(s) loose.

Multiple foot holds. Tighten.
Platform edge timber/s are loosening allowing access of the finger probe. Secure timber ensuring a gap less than 8 mm.

Prevent further damage.

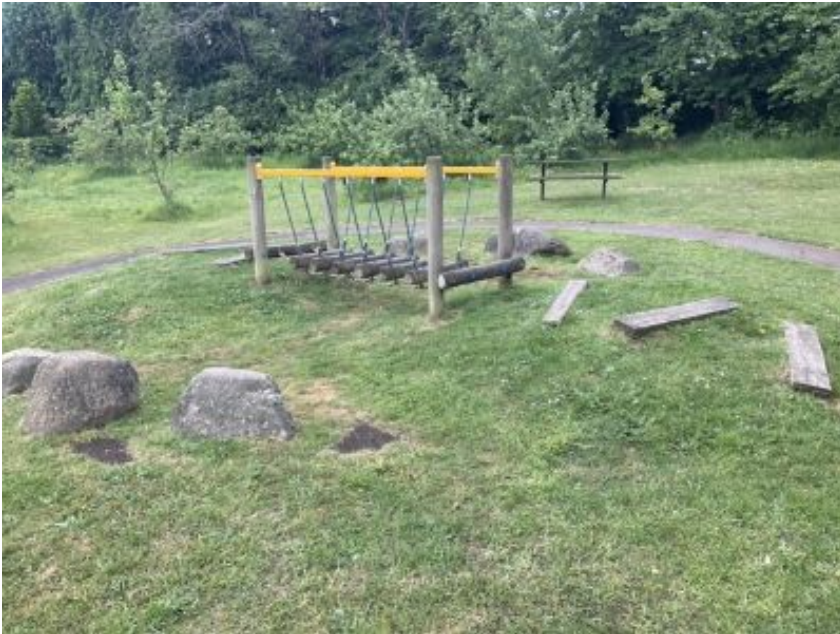
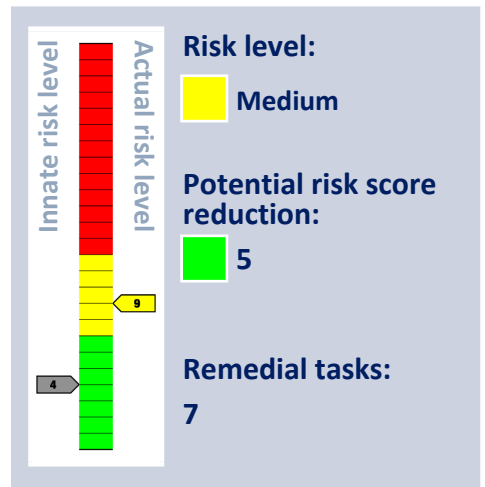
Agility - Clatter Bridge Trail - 3 Elements

Strimmer damage is present on posts, allowing water to enter and timbers to soften. It can also remove the protective envelope around the timber. Prevent further damage and check timbers for decay throughout the year.

Prevent further damage., Read the notes for further action.

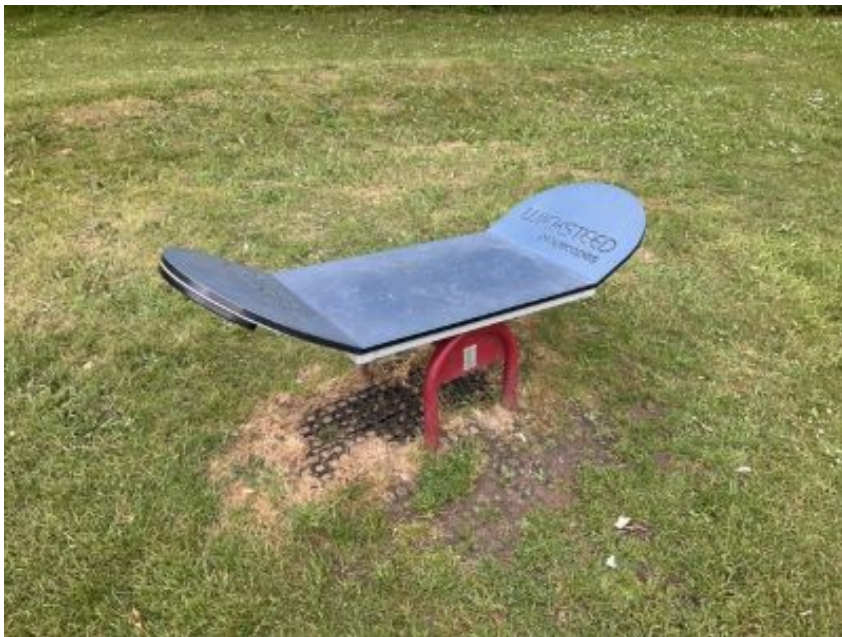
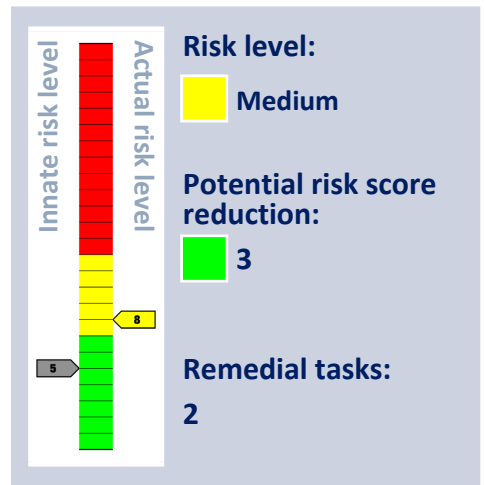
Agility - Wobble Board

Grinding inside bearing. Dismantle and replace affected parts.
