Safety Inspection Report

Annual Inspection

Play Area off Garden Road

Woolmer Green Parish Council

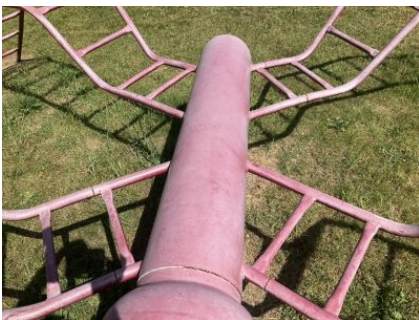
There is a head entrapment.

Small gaps where are less than 230 mm.

The unit was installed prior to the publication of the current standards. There is no requirement to make retrospective changes.

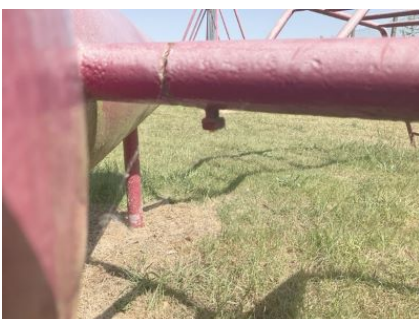
Hard or sharp projections.

Bolt head projecting.

Read the notes for further action.

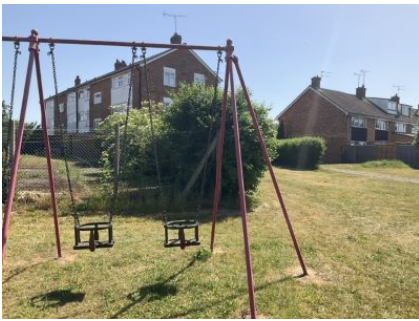
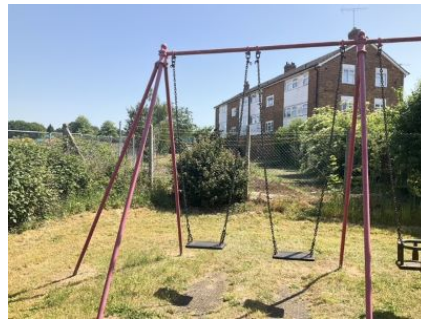
The distance between the seat side and the support is insufficient.

The unit was installed prior to the publication of the current standards. There is no requirement to make retrospective changes.

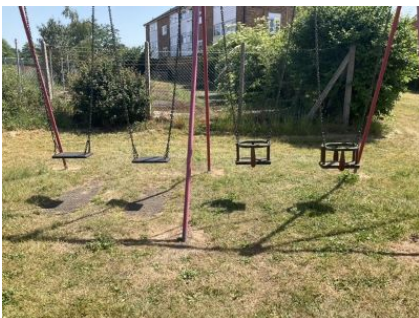
The distance between the seats is insufficient.

The unit was installed prior to the publication of the current standards. There is no requirement to make retrospective changes.

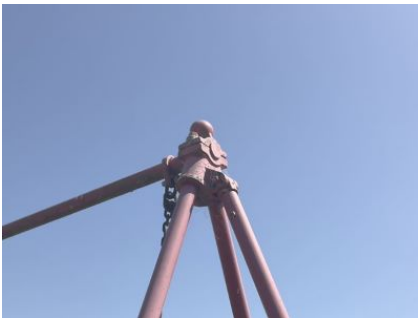
The manufacturer of this equipment advises that due to its age it cannot guarantee its stability and that the item should be removed.

Follow the manufacturer's guidance.

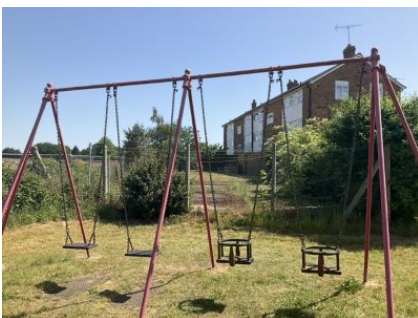
Bird fouling present.

Consider fitting an anti-bird strip or upward-facing cable ties to the top bar to prevent birds from landing. It is recommended that playground equipment be regularly checked for bird fouling - if found, the affected items should be cleaned with a disinfectant solution.

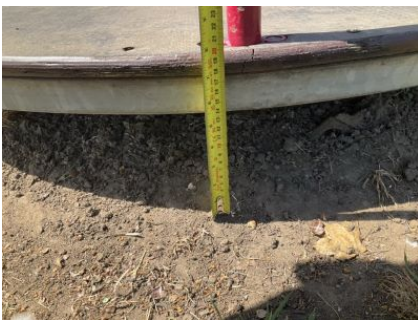
Clearance between the underside of the roundabout and the surface is incorrect.

Greater than 110 mm in areas.

Re-install roundabout or adjust surfacing. Recommended height 60-110 mm for 300 mm from edge.

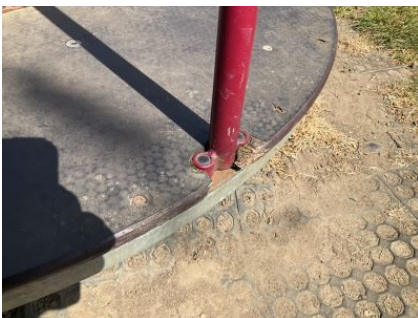
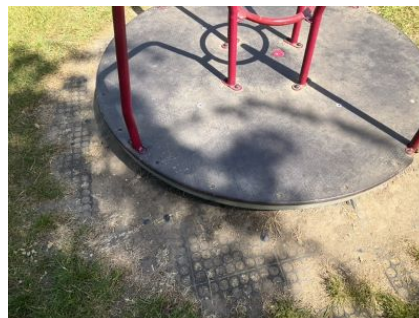
Laminate damaged.

Section missing. Replace.
Repair slightly wearing edges.

Replace.

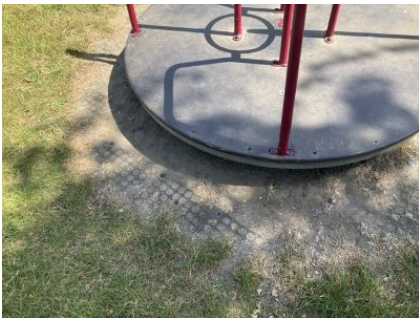
Item has some parts missing.

Matting sections. Replace.
Remove grass underneath unit.

Read the notes for further action.

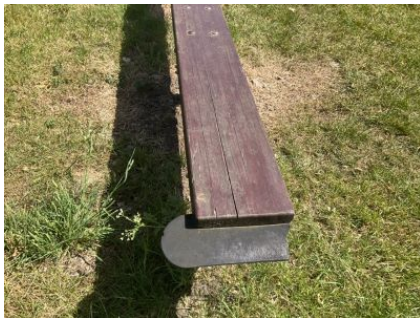
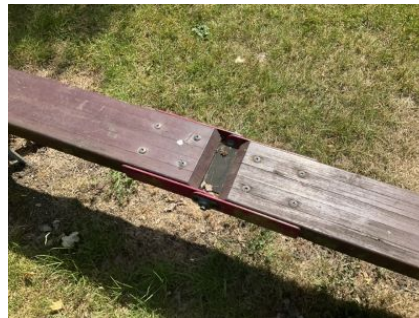
There are natural splits / shakes in the timbers.

Shakes and separations of the laminates.

DO NOT fill shakes. Monitor and sand back any splintered edges as required., DO NOT fill shakes. Shakes vary. Monitor and consult manufacturer if dimensions exceed 8 mm at sections used to grip / grasp., DO NOT fill shakes. There are shakes running through fixing points. Ensure the fixings are fully secure on regular basis.

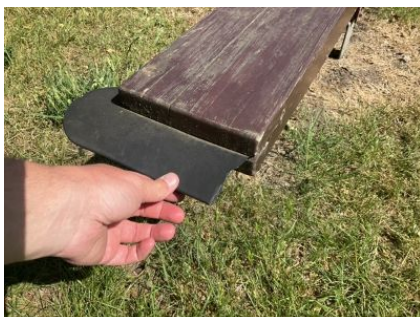
Item is damaged.

End rubber/s. Replace when necessary.

Replace.

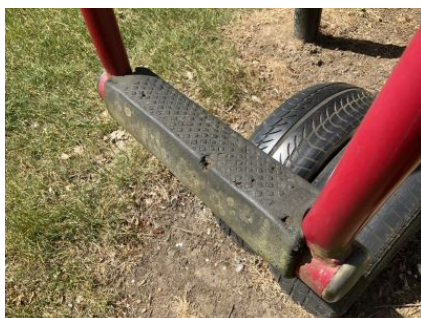
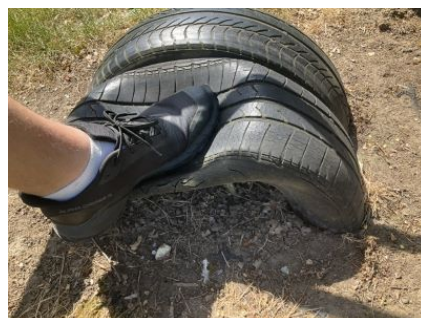
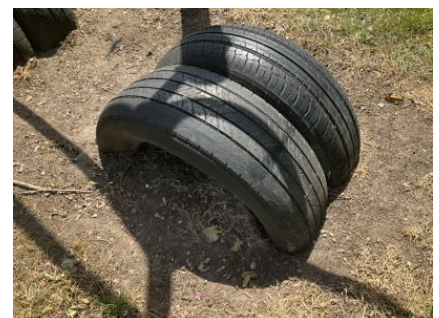
Item is worn.

Rubber foot holds and tyre dampeners. Replace in the near future.

Read the notes for further action.

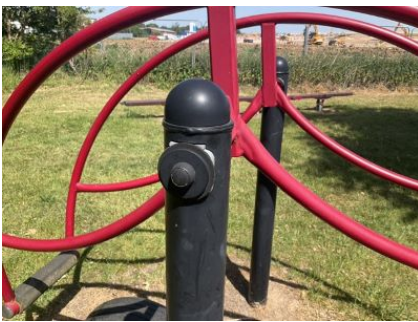
The supporting components should be dismantled and inspected according to the manufacturer's instructions. This will need doing on a regular basis, as defined by the manufacturer. This can lead to a high risk if no action is taken.

Noisy in operation.

Dismantle and inspect according to manufacturer's instructions.

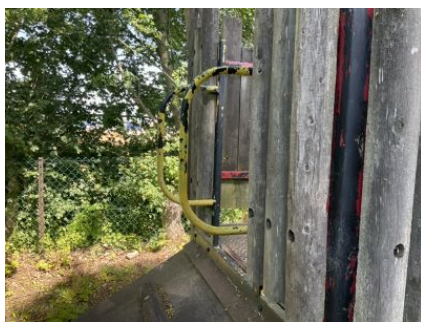
There is a head entrapment.

Slide and ramp hand rails.

The unit was installed prior to the publication of the current standards. There is no requirement to make retrospective changes.

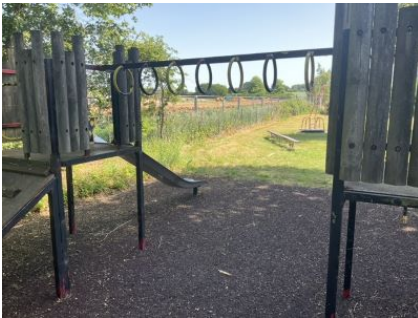
Overhead ladders and rings provide significant play value and benefits to children, and with it the risk of falling. Ensuring the surface remains in good condition will help to keep the correct balance between benefits and risk.

The protective surface under all bars and rings must be kept in good condition.

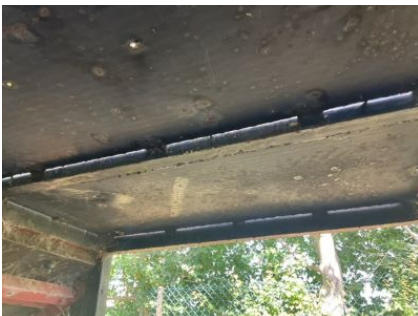
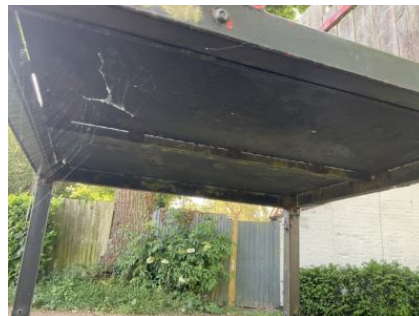
Item is rusting in places.

Platforms.

Descale.

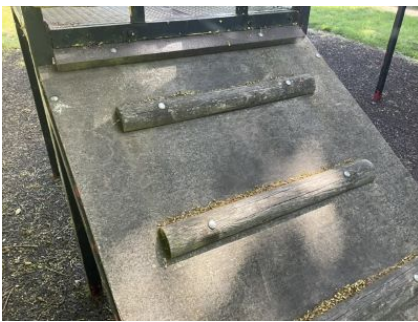
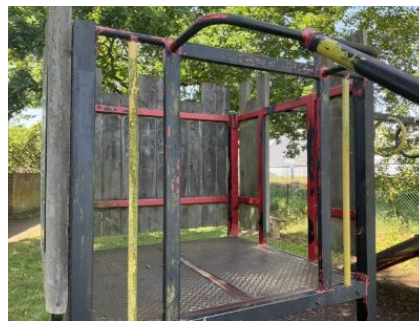
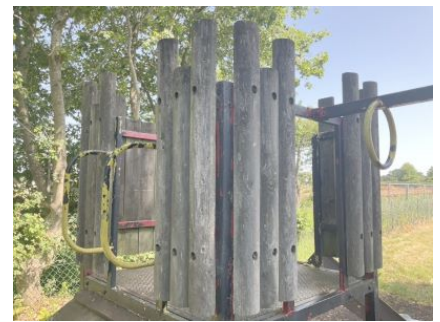
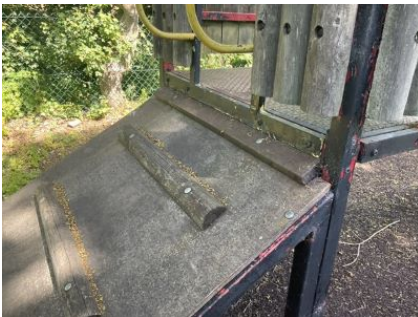
Bolt(s) loose.

Several barrier logs and ramp fixings are loose. Tighten.
Foot holds on ramp. Secure.

Tighten.

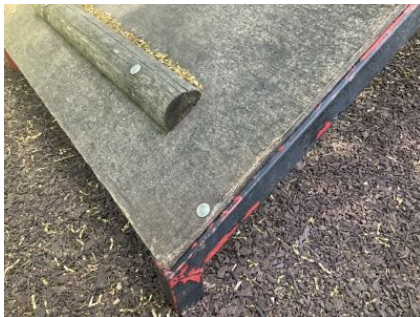
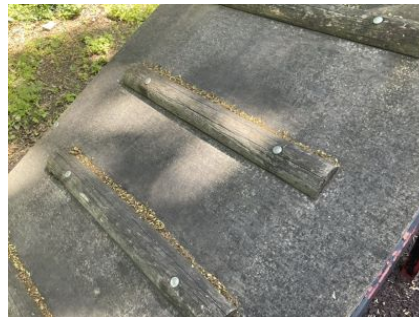
Laminate damaged.

Laminates and timber footholds. Repair.

Rub down and treat damaged edges.

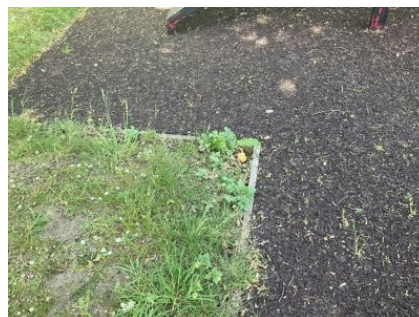
Trip points on the surface.

Around perimeters of unit. Build up ground levels and seed.

Build up surface level to remove trip points.
