# Safety Inspection Report

Annual Inspection

## Village Hall Play Area

Woolmer Green Parish Council

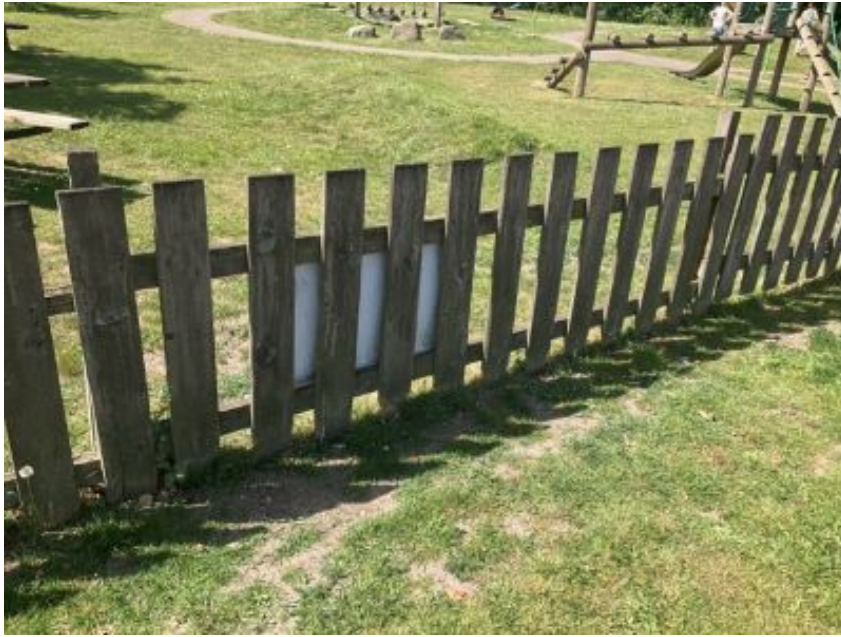
# Fencing

Moderate repairs are needed.

Monitor all timber items for decay throughout the year due to softening at ground level. Replace affected parts if found.  
Multiple loose posts. Check for decay at ground level and reset if not found.

Check on a routine basis., Replace.

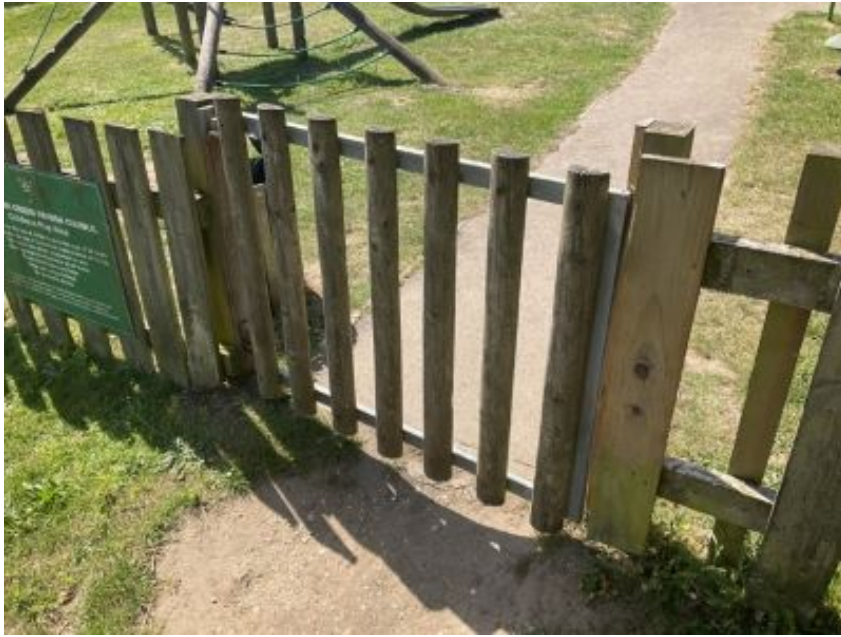
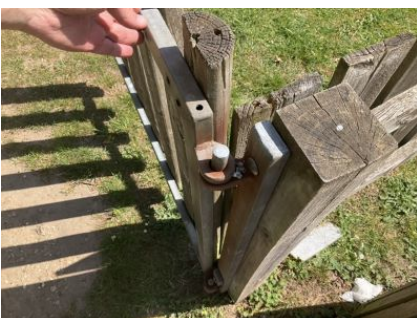
# Gates

There is a crushing or shearing point on the side of the gate. Where the gaps reduce to less than 12 mm these have been known to cause serious, permanent injury to children, especially on the hinge side where the leverage forces are significant.

Gate to hinge post and frames.

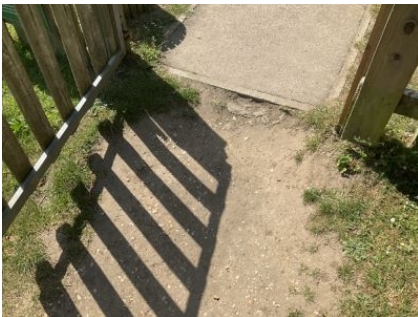
Surface is wearing.

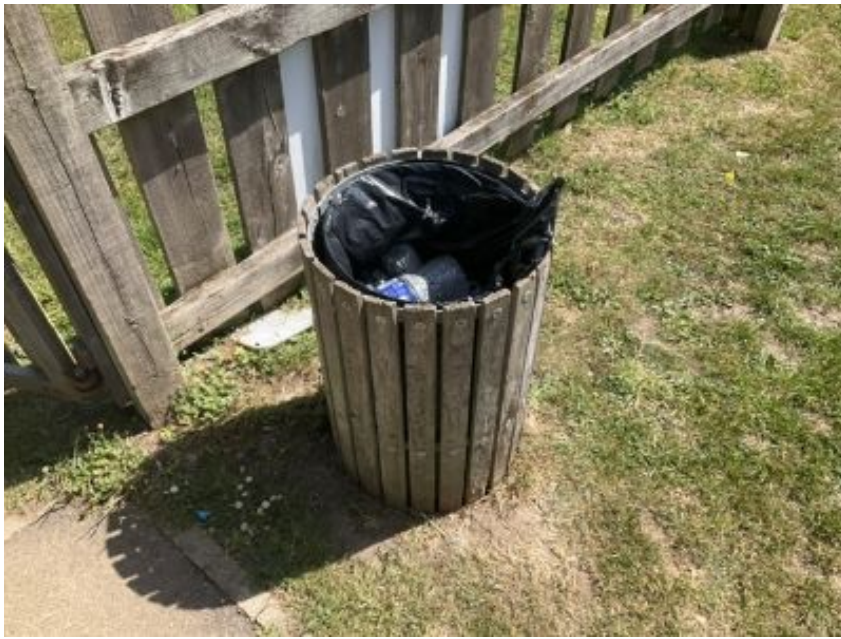
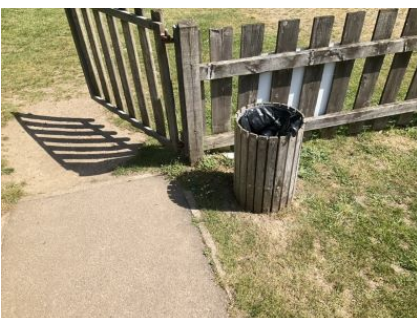
# Litter Bin

RoSPA recommends that litter bins should not be closer than 2 m from seats and gates (max of 3 m recommended). If they are too far away they may not be used. If they are too close this may cause nuisance from wasps.

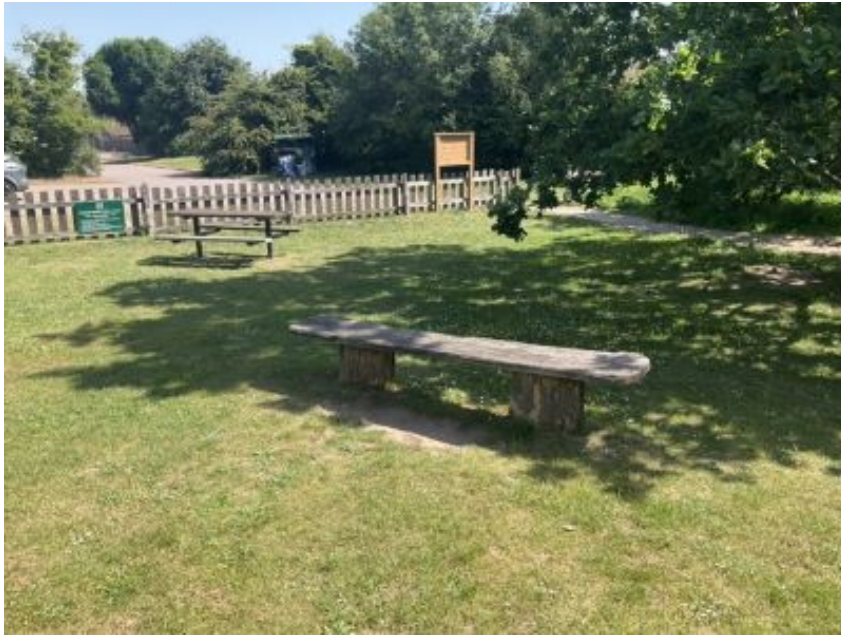
# Seating

Timber is not in good condition.

Benches. Recommended these are replaced due to excessive levels of decay and loose sections.  
Decaying picnic table timbers. Replace when necessary.

Replace., Repair.

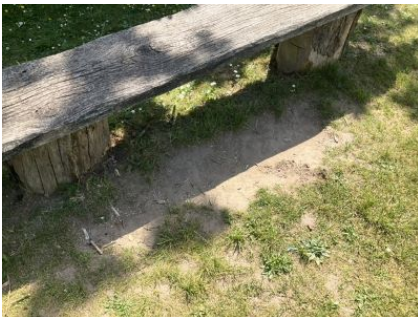
Worn ground areas.

Build up ground levels to remove trip hazard.

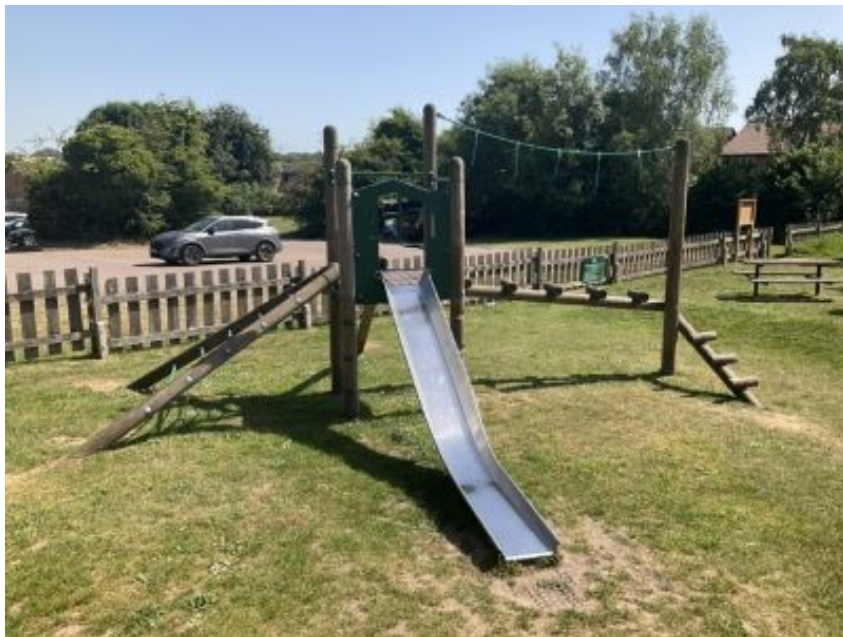
# Multiplay - Slide Climber

1. Strimmer damage is present on posts, allowing water to enter and timbers to soften. It can also remove the protective envelope around the timber. Prevent further damage and check timbers for decay throughout the year.
2. Bolt(s) loose.
3. Timber is splintered.

Prevent further damage.

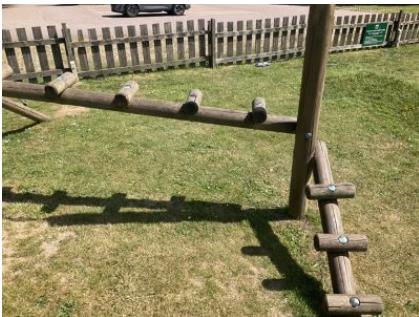
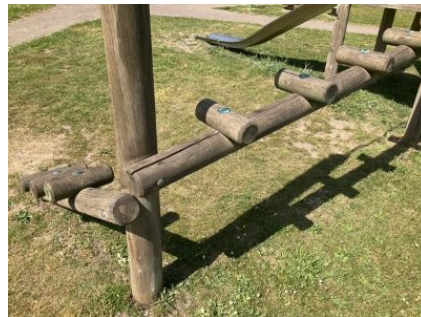
Bolt(s) loose.

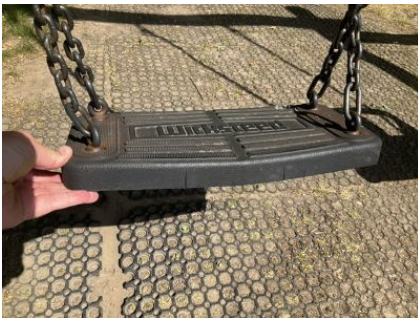
Swing seat rubber is deteriorating / degrading.

Replace when metal is exposed.

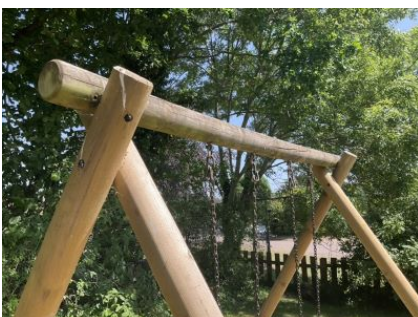
We are unable to determine the condition of the timbers. Resistance penetration testing can be undertaken to give a better indication of decay levels.

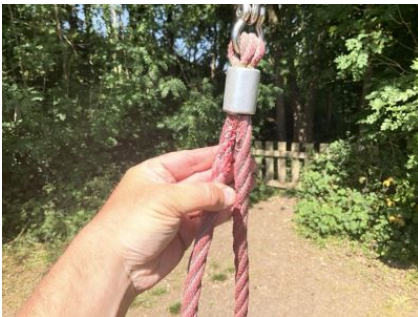
Due to arson damage. Tape over and replace when the metal core is damaged.

Repair.

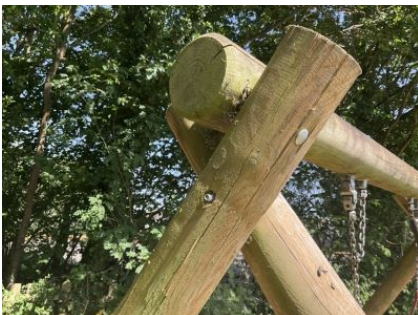
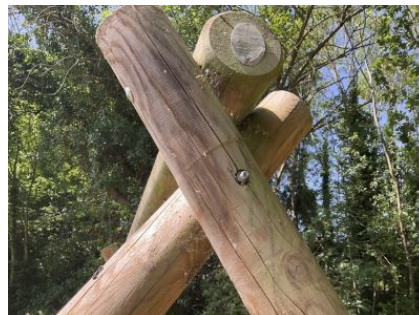
Cap missing.

Cap/s are missing allowing water ingress into the frame and fixtures. Replace.

Replace.

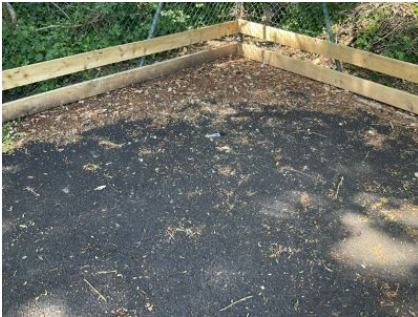
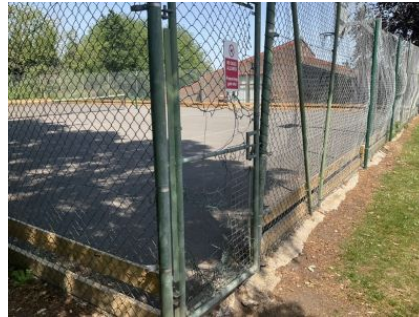
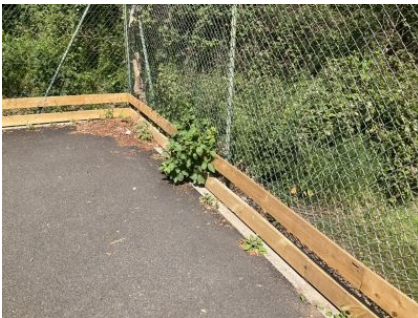
Moderate repairs are needed.

Mesh areas are damaged, loose and missing throughout. Repair and replace. Cut back all encroaching bushes and trees. Surface/the equipment are algae and moss covered, providing a slippery surface when wet. Sweep regularly.

Repair., Replace.

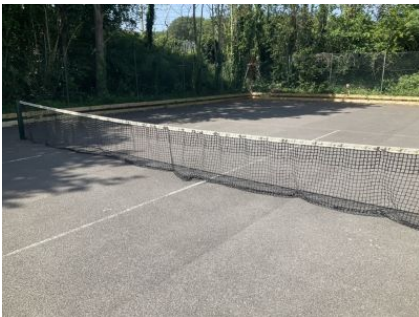
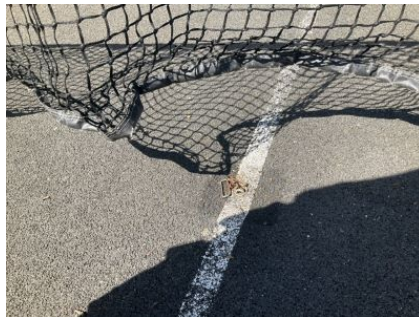
Item has some parts missing.

Central net links to foundation links.

Replace the missing parts.
